ASBESTOS INSPECTION REPORT
For Demolition

APEC Sampling Reference: Building #11
Housing Authority Reference: Building 45-I

Prepared for:
Pueblo Housing Authority

Date(s) of Inspection: 10/13/2021
Date(s) of Report: 11/11/2021

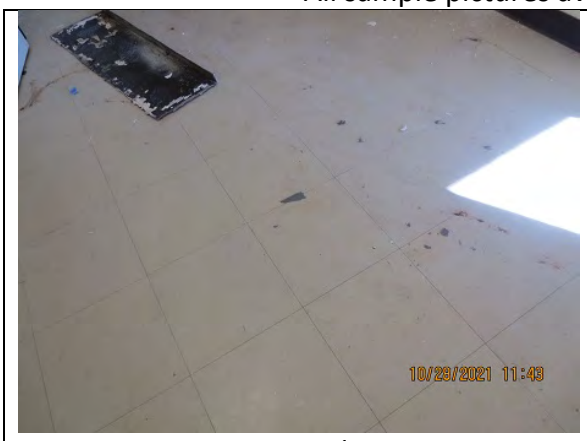
The 12X12 VCT Floor tile (5A & 5B) observed on the Floors of the entire structure are confirmed to be an **ACM** regulated material by Initial PLM method:

The materials assessed were in Good condition at the time of the inspection and Non-friable.

12X12 VCT Floor tile/Mastic (ACM)

12x12 VCT Floor Mastic/Mastic (ACM)
